**Flood Control Project Maintenance
Levee Inspections**

Maintenance Issue Types Only, Levee Inspection Report By Mile - Spring 2018

Sutter Maintenance Yard Maintenance Area 0016

Waterway	Bank	Unit Miles	Inspection Start/End	Inspector
Unit No. 01 Feather River	Right	4.06	03/20/2018 03/20/2018	Sterling York

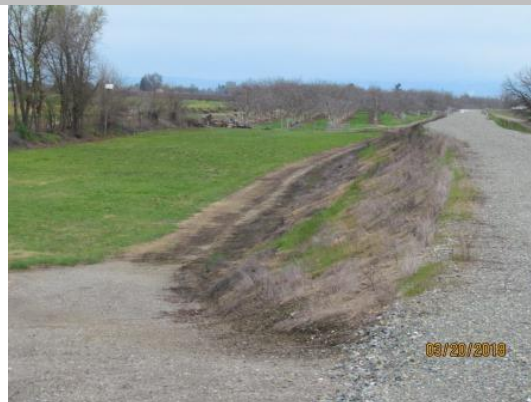
Photo 1 of 1 : SP_2018_MA0016_302_8_20180402_00013.jpg

LM Start	0.01	Rating **	A	Issue No.	8
LM End	4.05	Issue Type +	Ma	Location *	LS
Category	Earthen Levee			GPS Latitude/Longitude	
				Start	End
Item	Vegetation			39.310826 °	39.310826 °
				-121.636395 °	-121.637674 °
DWR ID	DWR_MA0016_01_s_2018_8				
Comment Code					
V1 : Control annual grass and weeds on the levee slopes and easements.					
Inspector Comment					
The annual vegetation is well maintained, Spring 2017.

View looking upstream landside of the well maintained annual vegetation, Spring 2018.

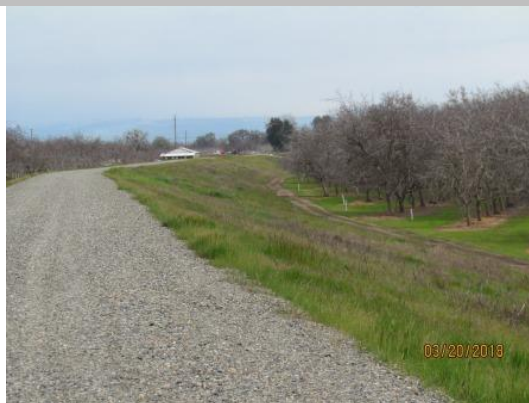
Photo 1 of 1 : SP_2018_MA0016_302_7_20180402_00014.jpg

LM Start	0.01	Rating **	A	Issue No.	7
LM End	4.05	Issue Type +	Ma	Location *	WS
Category	Earthen Levee			GPS Latitude/Longitude	
				Start	End
Item	Vegetation			39.255964 °	39.310826 °
				-121.636421 °	-121.637674 °
DWR ID	DWR_MA0016_01_s _ 2018_7				
Comment Code					
V1 : Control annual grass and weeds on the levee slopes and easements.					
Inspector Comment					
The annual vegetation is well maintained, Spring 2017.

View looking upstream waterside of the well maintained annual vegetation, Spring 2018.

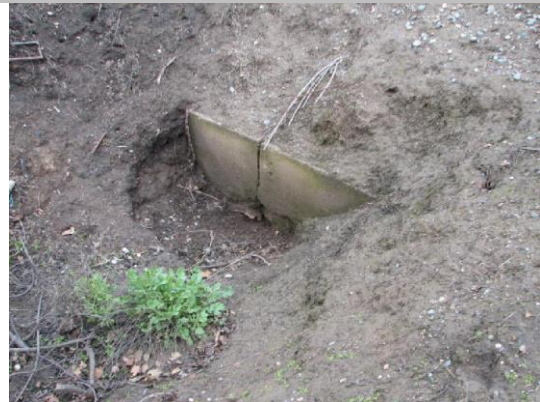
Photo 1 of 2 : UCIP_SP_2018_51931_65782.jpg

Comment Code					
Inspector Comment					
FS_ID:51931 DS_ID:17125 EP_NO: N/A Repair Type: Non-Urgent Crossing Status: Found UCIP Comments: 5/22/2017 LS inlet buried. WS access being blocked off by over grown vegetation. Pipe has been selected for internal cleaning and inspection as part of the DMP project. (DWR Sutter Yard - A/Freitag)12/1/2016 LS inlet completely buried. (DWR Sutter Yard- A/Freitag)5/26/2016 LS inlet was completely buried.6/8/2015 Concrete headwall is still cracked and inlet is buried. It was said to be replaced with the SBFCA project but the project skipped over in this area.12/29/2014 Same as last inspection.5/19/2014 Same as last inspection.11/6/2013 Same as last inspection.5/14/2013 SBFCA project recommends replacing in accordance with title 23. Same as last inspection.12/11/2012 Concrete headwall on LS toe is cracked through middle and pipe is buried in soil. pipe appears corroded. FIELD_STRUCT_DESC: 1 of 2: 24-inch corrugated metal drainage pipe through the levee, 16.6 feet below the crown. Concrete headwalls on both the waterside (WS) and the landside (LS) ends. Flap gate on the WS end. [Additional Reference(s): DWR Levee Log, 2005. USACE Sacramento O&M Manual 148, August 1955, (Station 646+96)]. FS Date: 5/31/2017 7:29:38 AM

Headwall at LS toe is cracked and the inlet is buried in soil.

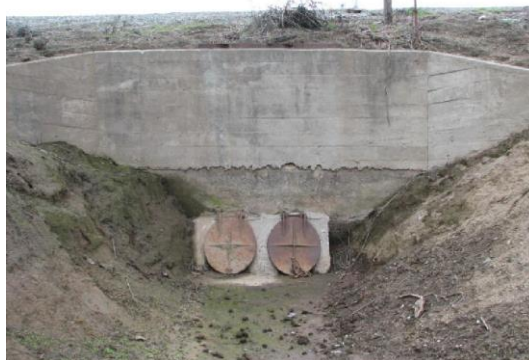
Photo 2 of 2 : UCIP_SP_2018_51931_65781.jpg

FS_ID:51931
DS_ID:17125
EP_NO: N/A
Repair Type: Non-Urgent
Crossing Status: Found
UCIP Comments: 5/22/2017 LS inlet buried. WS access being blocked off by over grown vegetation. Pipe has been selected for internal cleaning and inspection as part of the DMP project. (DWR Sutter Yard - A/Freitag)12/1/2016 LS inlet completely buried. (DWR Sutter Yard - A/Freitag)5/26/2016 LS inlet was completely buried.6/8/2015 Concrete headwall is still cracked and inlet is buried. It was said to be replaced with the SBFCA project but the project skipped over in this area.12/29/2014 Same as last inspection.5/19/2014 Same as last inspection.11/6/2013 Same as last inspection.5/14/2013 SBFCA project recommends replacing in accordance with title 23. Same as last inspection.12/11/2012 Concrete headwall on LS toe is cracked through middle and pipe is buried in soil. pipe appears corroded.
FIELD_STRUCT_DESC: 1 of 2: 24-inch corrugated metal drainage pipe through the levee, 16.6 feet below the crown. Concrete headwalls on both the waterside (WS) and the landside (LS) ends. Flap gate on the WS end. [Additional Reference(s): DWR Levee Log, 2005. USACE Sacramento O&M Manual 148, August 1955, (Station 646+96)].

Headwall on WS toe with flap gates.

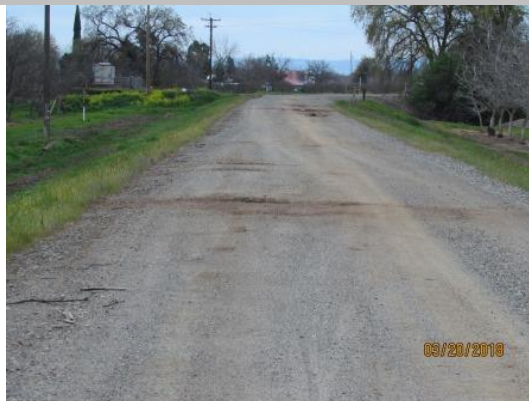
Photo 1 of 1 : SP_2018_MA0016_302_11_20180402_00017.jpg

LM Start	3.94	Rating **	M	Issue No.	11
LM End	4.09	Issue Type +	Ma	Location *	CR
Category	Earthen Levee		GPS Latitude/Longitude		
			Start	End	
Item	Crown Surface / Depressions / Rutting		39.309154 °	39.311298 °	
			-121.637694 °	-121.637554 °	
DWR ID	DWR_MA0016_01_s_2018_11

View looking upstream of the crown that needs aggregate base added for an all weather access road which is scheduled for summer 2018, Spring Inspection 2018.

C1 : Add appropriate material and re-grade the levee to bring the crown above the design elevation.

Re-grading and aggregate base is scheduled for summer 2018.
